**Flood Control Project Maintenance
Levee Inspections**
LMA District Cover Sheet
Spring 2018 Levee Inspection Results

Reclamation District No. 0010 Honcut

Spring 2018 Levee Inspection Results

Waterway			Bank	Unit Miles
Unit No. 01 Simmerly Slough			Right	7.65
	Spring (March - May)	Summer (June - August)	(September - November) Fall	Winter (December - February)
Unit Maintenance Rating (Fall Only)				
Date of Inspection	4/10/2018 - 4/10/2018			
DWR Inspector	Sterling York			
Accompanied By	Finlay Williams

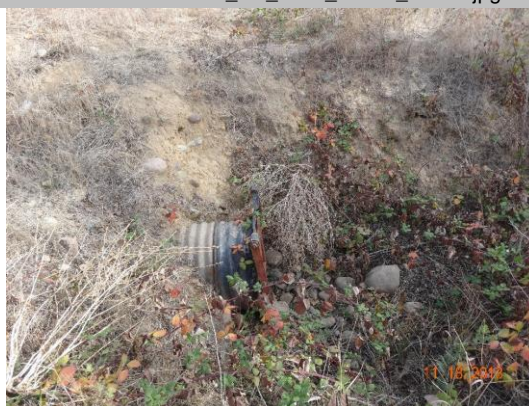
Photo 3 of 3 : UCIP_SP_2018_27791_51504.jpg

LM Start	0.00	Rating **	M	Issue No.	67 (cont)	
LM End	0.00	Issue Type +	Ma	Location *		
Category	Supplemental			GPS Latitude/Longitude		
				Start		End
Item	DWR UCIP LMA Responsibility			39.169234 °	39.169234 °	
				-121.586203 °	-121.586203 °	
DWR ID						
Comment Code						
Inspector Comment						
FS_ID:27791 DS_ID:21268 EP_NO: N/A Repair Type: Non-Urgent Crossing Status: Found UCIP Comments: Vegetation has been cleared from slope. This crossing is referenced in the USACE Periodic Inspection as item USACE_CESPK_HON1_2013_p_0158. FIELD_STRUCT_DESC: 24-inch corrugated metal gravity drainage pipe through the levee, 30 feet below the crown. Flap gate on the waterside (WS) end. Slide gate on the landside (LS) end. Concrete saddle and apron on the WS. [Additional Reference(s): DWR Levee Log, 2005. USACE Sacramento O&M Manual 151, May 1953, (Station 1+00)]. FS Date: 4/29/2013

View of pipe and flap gate located on waterward side.

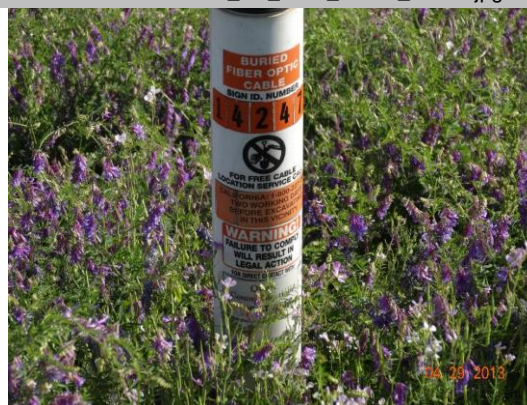
Photo 1 of 2 : UCIP_SP_2018_27712_51365.jpg

LM Start	0.23	Rating **	M	Issue No.	68
LM End	0.23	Issue Type +	En	Location *	
Category	Supplemental			GPS Latitude/Longitude	
				Start	End
Item	DWR UCIP Field Study			39.163407 °	39.163407 °
				-121.605645 °	-121.605645 °
DWR ID					
Comment Code					
Inspector Comment					
FS_ID:27712					
DS_ID:24653					
EP_NO: N/A					
Repair Type: Non-Urgent					
Crossing Status: Indicator Found					
UCIP Comments: Need to contact owner--unable to determine if crossing is authorized (no permit found) also need to determine if crossing goes through levee.					
FIELD_STRUCT_DESC: Fiber optics line markers on the levee slope.					
Unable to determine if this line goes through the levee. This line was field discovered.					
FS Date: 4/29/2013

Contact information for buried fiber optic cable.

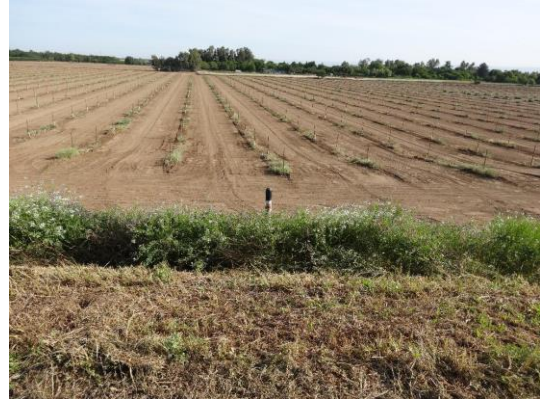
Photo 2 of 2 : UCIP_SP_2018_27712_51364.jpg

LM Start	0.23	Rating **	M	Issue No.	68 (cont)	
LM End	0.23	Issue Type +	En	Location *		
Category	Supplemental			GPS Latitude/Longitude		
				Start		End
Item	DWR UCIP Field Study			39.163407 °		39.163407 °
				-121.605645 °		-121.605645 °
DWR ID						
Comment Code						
Inspector Comment						
FS_ID:27712						
DS_ID:24653						
EP_NO: N/A						
Repair Type: Non-Urgent						
Crossing Status: Indicator Found						
UCIP Comments: Need to contact owner--unable to determine if crossing is authorized (no permit found) also need to determine if crossing goes through levee.						
FIELD_STRUCT_DESC: Fiber optics line markers on the levee slope.						
Unable to determine if this line goes through the levee. This line was field discovered.						
FS Date: 4/29/2013

Marker visible on landward side.

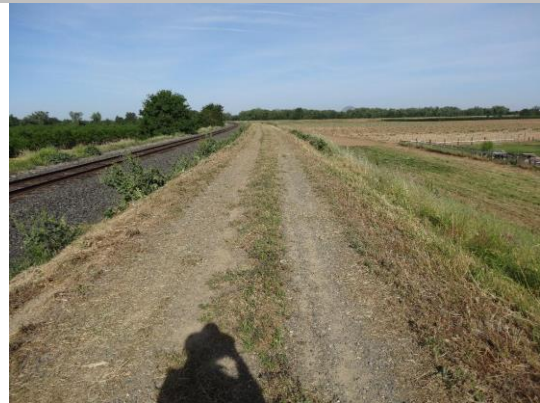
Photo 1 of 3 : UCIP_SP_2018_24806_44540.jpg

Comment Code						
Inspector Comment						
FS_ID:24806 DS_ID:21257 EP_NO: 13015 Repair Type: Non-Urgent Crossing Status: Found UCIP Comments: New gravel indicates work was recently completed. Will need to contact owner to obtain information pertaining to work completed. Need to contact owner to determine if crossing is still active and to determine last inspection date. Will need copy of letter showing crossings passed inspection. This crossing is referenced in the USACE Periodic Inspection as item USACE_CESPK_HON1_2013_p_0075. FIELD_STRUCT_DESC: 4-inch steel natural gas pipeline sleeved through an 8-inch pipe through the levee, 30 feet below the crown. Annular space grouted. Cutoff wall on each end within the levee. (Plans to reinforce an existing 4-inch gas main with a parallel 4-inch main through the levee authorized under Permit No. 13015, 1980 - Pacific Gas and Electric Company [PG&E]). [Additional Reference(s): DWR Levee Log, 2005]. FS Date: 4/29/2013

View of levee crown looking upstream.

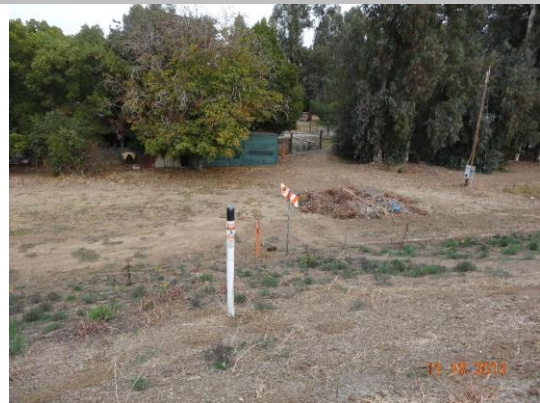
Photo 3 of 3 : UCIP_SP_2018_24806_44543.jpg

FS_ID:24806
DS_ID:21257
EP_NO: 13015
Repair Type: Non-Urgent
Crossing Status: Found
UCIP Comments: New gravel indicates work was recently completed. Will need to contact owner to obtain information pertaining to work completed. Need to contact owner to determine if crossing is still active and to determine last inspection date. Will need copy of letter showing crossings passed inspection. This crossing is referenced in the USACE Periodic Inspection as item USACE_CESPK_HON1_2013_p_0075. FIELD_STRUCT_DESC: 4-inch steel natural gas pipeline sleeved through an 8-inch pipe through the levee, 30 feet below the crown. Annular space grouted. Cutoff wall on each end within the levee. (Plans to reinforce an existing 4-inch gas main with a parallel 4-inch main through the levee authorized under Permit No. 13015, 1980 - Pacific Gas and Electric Company [PG&E]). [Additional Reference(s): DWR Levee Log, 2005].

View of landward side--gas marker and conduit line marker.

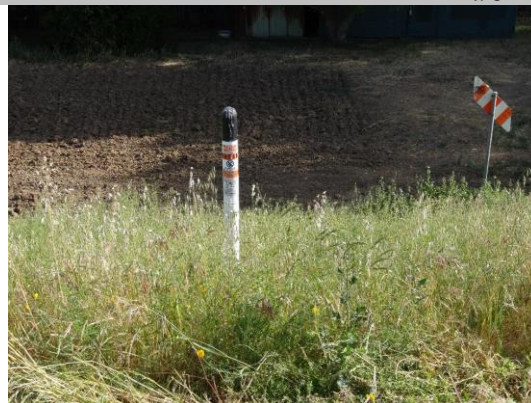
Photo 1 of 2 : UCIP_SP_2018_27713_51366.jpg

LM Start	0.41	Rating **	M	Issue No.	70
LM End	0.41	Issue Type +	En	Location *	
Category	Supplemental			GPS Latitude/Longitude	
				Start	End
Item	DWR UCIP Field Study			39.162853 °	39.162853 °
				-121.602435 °	-121.602435 °
DWR ID					
Comment Code					
Inspector Comment					
FS_ID:27713					
DS_ID:24654					
EP_NO: N/A					
Repair Type: Non-Urgent					
Crossing Status: Indicator Found					
UCIP Comments: Need to contact owner--unable to determine if crossing is authorized (no permit found) also need to determine if crossing goes through levee.					
FIELD_STRUCT_DESC: Fiber optics line markers on levee slope.					
Unable to determine if line goes through the levee. This line was field discovered.					
FS Date: 4/29/2013

View of landward side--communication line marker.

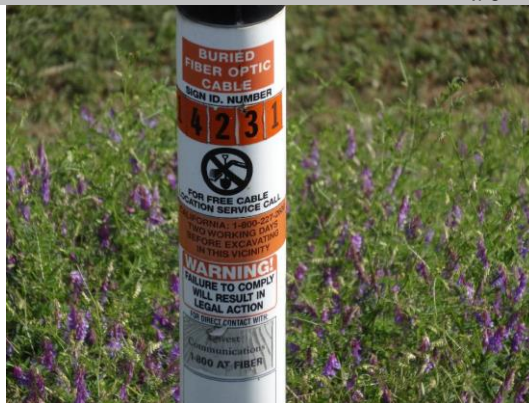
Photo 1 of 2 : UCIP_SP_2018_27710_51361.jpg

LM Start	0.53	Rating **	M	Issue No.	71
LM End	0.53	Issue Type +	En	Location *	
Category	Supplemental			GPS Latitude/Longitude	
				Start	End
Item	DWR UCIP Field Study			39.162277 °	39.162277 °
				-121.600219 °	-121.600219 °
DWR ID					
Comment Code					
Inspector Comment					
FS_ID:27710 DS_ID:24655 EP_NO: N/A Repair Type: Non-Urgent Crossing Status: Indicator Found UCIP Comments: Need to contact owner--unable to determine if crossing is authorized (no permit found) also need to determine if crossing goes through levee. FIELD_STRUCT_DESC: Fiber optics line markers on levee slope. Unable to determine if line goes through the levee. This line was field discovered. FS Date: 4/29/2013

Contact information for fiber optic cable and ID number.

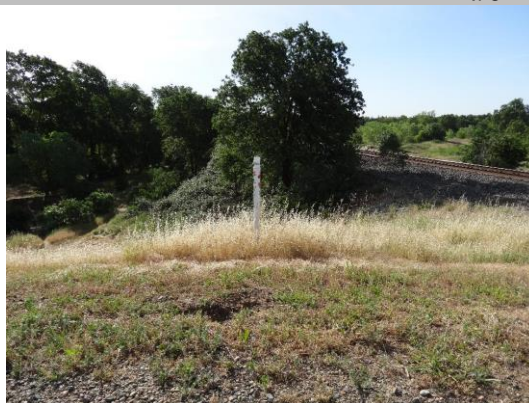
Photo 1 of 2 : UCIP_SP_2018_27715_51371.jpg

LM Start	0.72	Rating **	M	Issue No.	72
LM End	0.72	Issue Type +	En	Location *	
Category	Supplemental			GPS Latitude/Longitude	
				Start	End
Item	DWR UCIP Field Study			39.161229 °	39.161229 °
				-121.597072 °	-121.597072 °
DWR ID					
Comment Code					
Inspector Comment					
FS_ID:27715					
DS_ID:24656					
EP_NO: N/A					
Repair Type: Non-Urgent					
Crossing Status: Indicator Found					
UCIP Comments: Need to contact owner--unable to determine if crossing is authorized (no permit found) also need to determine if crossing goes through levee.					
FIELD_STRUCT_DESC: Fiber optics line markers on levee slope.					
Unable to determine if line goes through the levee. This line was field discovered.					
FS Date: 4/29/2013

View of marker located on waterward side.

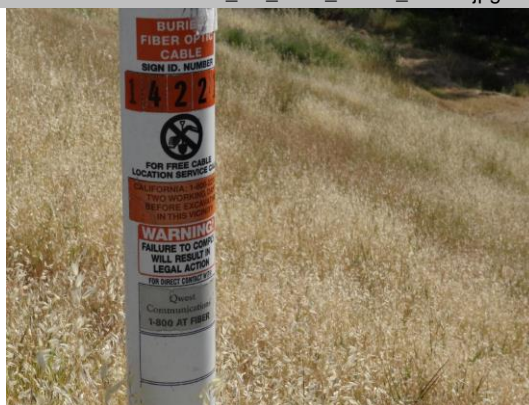
Photo 2 of 2 : UCIP_SP_2018_27715_51370.jpg

Contact information and ID number for buried fiber optic cable.

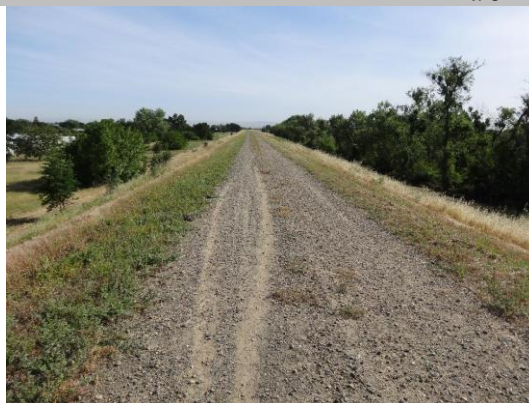
Photo 2 of 3 : UCIP_SP_2018_50058_51410.jpg

FS_ID:50058
DS_ID:21258
EP_NO: N/A
Repair Type: Non-Urgent
Crossing Status: Found
UCIP Comments: 7/01/2016 Gate has been repaired--WS gate is functional. LS gate still needs new stem for the gate to properly function--stem is bent. USACE's PI issue references permit number 13710 this is incorrect permit is associated with DS_ID 21259 (CLM 0.767). (DWR UCIP - omagana)4/29/2013 Damaged flap gate on waterward side and damaged stem on screw gate on landward side. Need to contact owner to determine if crossing is still active. If crossing is still in use owner will need to address damage on flap gate and screw gate. If crossing is no longer in use owner will need to contact the CVFPB to comply with Title 23. This crossing is referenced in the USACE Periodic Inspection as item USACE_CESPK_HON1_2013_p_0053 and 0057. (DWR UCIP - omagana)
FIELD_STRUCT_DESC: 24-inch corrugated metal gravity drainage pipe through the levee, 31 feet below the crown. Two corrugated metal cutoff walls around pipe. Concrete headwall at each end. Flap gate on the waterside (WS) end. Slide gate on the landside (LS) end. Pipe discharges into 6-foot concrete splash apron on the WS. [Additional Reference(s): DWR Levee Log, 2005. USACE Sacramento O&M Manual 151, May 1953, (Station 46+60)].

View of levee crown looking downstream.

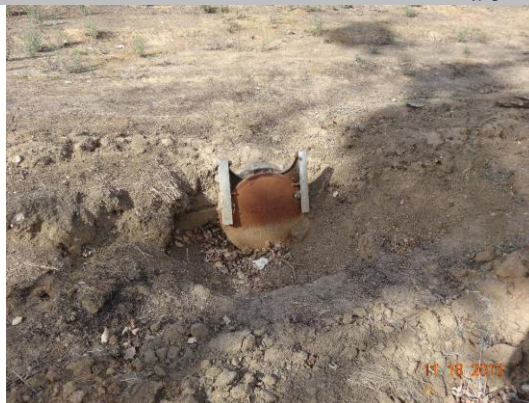
Photo 3 of 3 : UCIP_SP_2018_27748_51451.jpg

Comment Code						
Inspector Comment						
FS_ID:27748						
DS_ID:21261						
EP_NO: N/A						
Repair Type: No Action Needed						
Crossing Status: Found						
UCIP Comments: No signs of damage to levee present during inspection. This crossing is referenced in the USACE Periodic Inspection as item USACE_CESPK_HON1_2013_p_0037 and 0040.						
FIELD_STRUCT_DESC: 24-inch corrugated metal gravity drainage pipe through the levee, 29.5 feet below the crown. Two corrugated metal cutoff walls around the pipe on each end. Slide gate on the landside (LS) end. Flap gate on the waterside (WS) end. Concrete headwall at the LS toe. [Additional Reference(s): DWR Levee Log, 2005. USACE Sacramento O&M Manual 151, May 1953, (Station 37+66)].						
FS Date: 4/29/2013

View of flap gate located on waterward side.

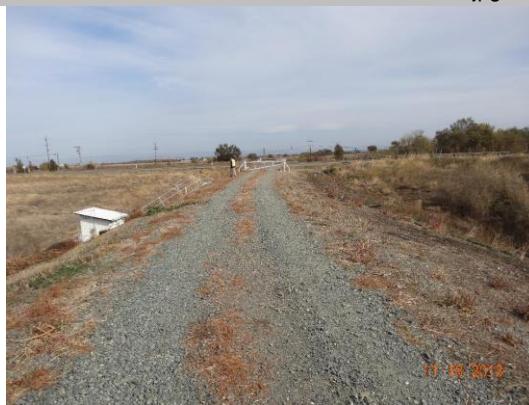
Photo 2 of 3 : UCIP_SP_2018_27725_51387.jpg

FS_ID:27725
DS_ID:21262
EP_NO: N/A
Repair Type: Non-Urgent
Crossing Status: Found
UCIP Comments: Crossing appears not to be in use--need to contact owner. Need to coordinate with owner to determine status of crossing. If crossing is no longer in use owner will need to contact the CVFPB to comply with Title 23. This crossing is referenced in the USACE Periodic Inspection as item USACE_CESPK_HON1_2013_p_0012.
FIELD_STRUCT_DESC: 10-inch steel irrigation discharge pipe through the levee, 7.3 feet below the crown. Siphon breaker in a corrugated metal pipe (CMP) riser on the waterside (WS) slope. Pump on the WS berm. Pump not present. Switch house on the WS slope. No switch house present. 24-inch concrete standpipe at the landside (LS) toe. Concrete pad is still present on the WS. [Additional Reference(s): DWR Levee Log, 2005. USACE Sacramento O&M Manual 151, May 1953, (Station 14+82)].
FS Date: 4/29/2013

View of levee crown looking downstream.

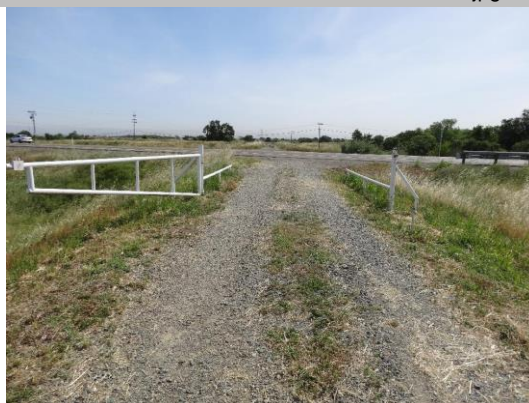
Photo 2 of 3 : UCIP_SP_2018_24811_44581.jpg

FS_ID:24811
 DS_ID:21264
 EP_NO: N/A
 Repair Type: No Action Needed
 Crossing Status: Found
 UCIP Comments: This crossing is referenced in the USACE Periodic Inspection as item USACE_CESPK_HON1_2013_p_0004.
 FIELD_STRUCT_DESC: [Reclamation District No. 10 (RD0010) Drainage Plant] 16-inch steel drainage discharge pipe through the levee, 7 feet below the crown. Steel cutoff plate around the pipe at the center of the levee. Siphon breaker on the landside (LS) slope. Flap gate on the waterside (WS) end. Pump in a pit at the LS toe with steps along the LS slope. Saddle and 8-foot splash apron at the discharge end of the pipe. Concrete headwall at the LS toe. Metal shed on the LS slope. [Additional Reference(s): DWR Levee Log, 2005. USACE Sacramento O&M Manual 151, May 1953, (Station 13+88)].
 FS Date: 4/29/2013

View of levee crown looking downstream--access gate near HWY 70.

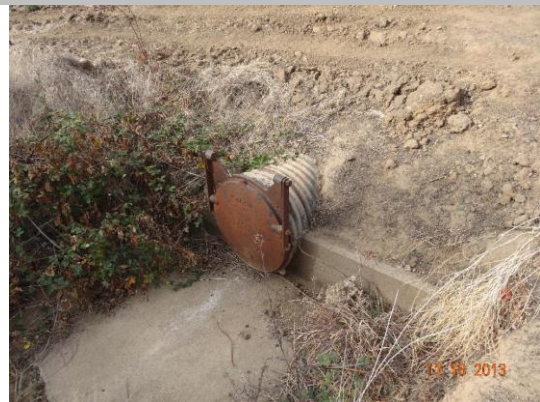
Photo 2 of 3 : UCIP_SP_2018_49986_44587.jpg

View of headwall, pipe, and flap gate located on WS.

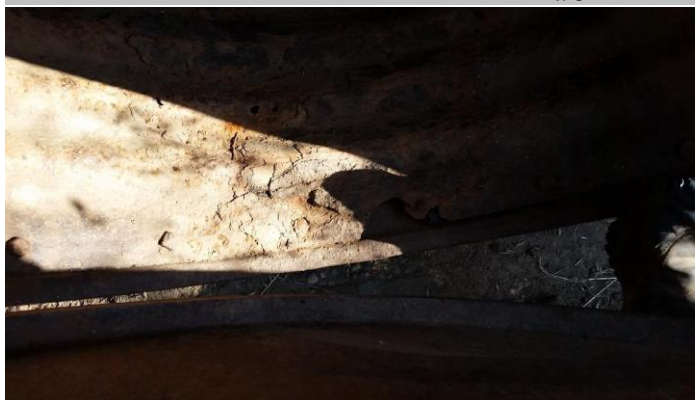
Photo 3 of 3 : UCIP_SP_2018_49986_75321.jpg

Deteriorated pipe wall at the outlet (WS).

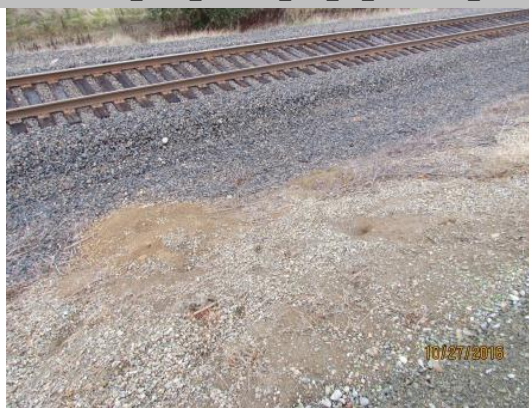
Photo 1 of 1 : SP_2018_RD0010_163_65_20180302_00033.jpg

View of squirrel holes on the landside, no rodent activity was observed.
Fall 2016.

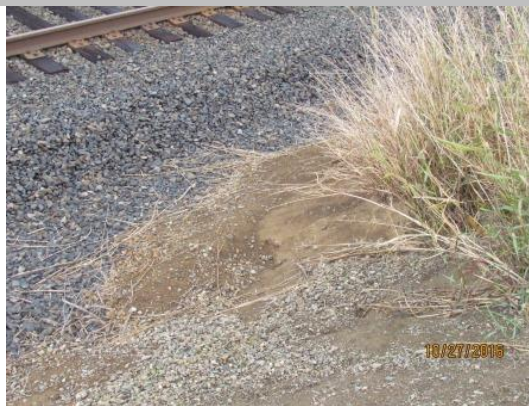
Photo 1 of 1 : SP_2018_RD0010_163_64_20180302_00032.jpg

View of squirrel holes on the landside, no rodent activity was observed.
Fall 2016.

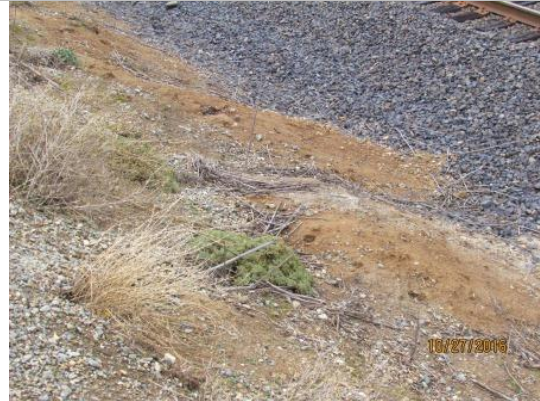
Photo 1 of 1 : SP_2018_RD0010_163_61_20180302_00030.jpg

View of squirrel holes on the landside slope and toe, no rodent activity was observed. Fall 2016.

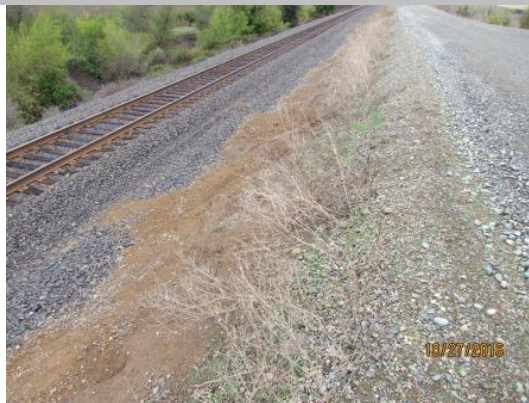
Photo 1 of 1 : SP_2018_RD0010_163_60_20180302_00029.jpg

View of squirrel holes on the landside slope and toe, no rodent activity was observed. Fall 2016.

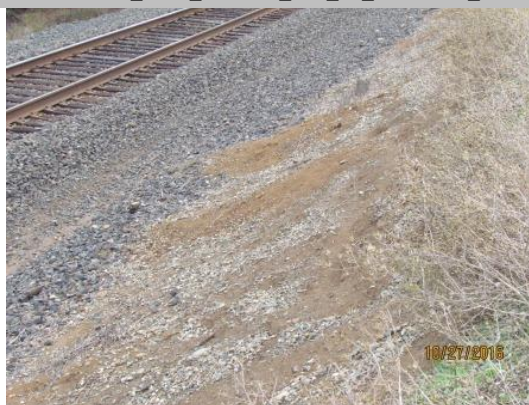
Photo 1 of 1 : SP_2018_RD0010_163_59_20180302_00028.jpg

View of squirrel holes on the landside slope and toe, no rodent activity was observed. Fall 2016.

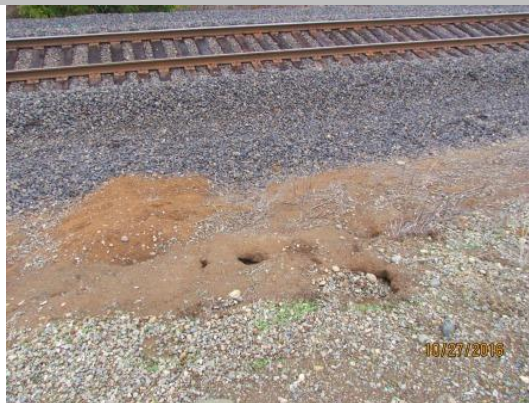
Photo 1 of 1 : SP_2018_RD0010_163_58_20180302_00027.jpg

View of squirrel holes on the landside slope and toe, no rodent activity was observed. Fall 2016.

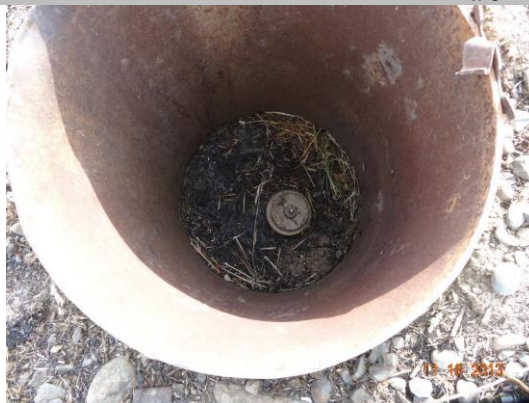
Photo 3 of 3 : UCIP_SP_2018_49987_44606.jpg

View of siphon breaker located inside steel riser.

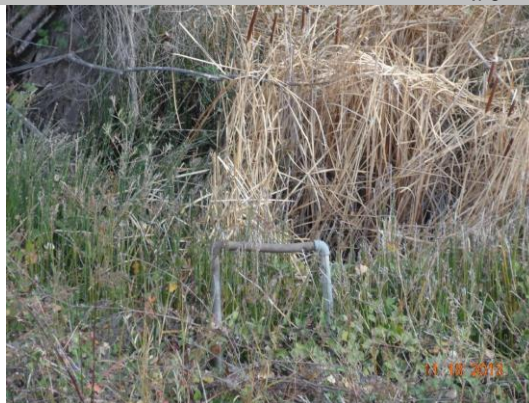
Photo 3 of 3 : UCIP_SP_2018_24816_44612.jpg

Unable to confirm crossing--only visible sign is U shaped pipe through vegetation.

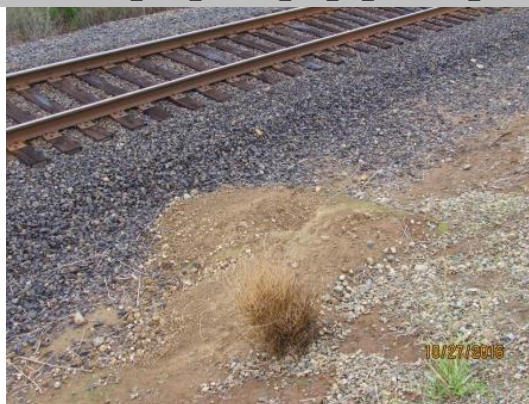
Photo 1 of 1 : SP_2018_RD0010_163_52_20180302_00023.jpg

View of squirrel holes on the landside slope and toe, no rodent activity was observed. Fall 2016.

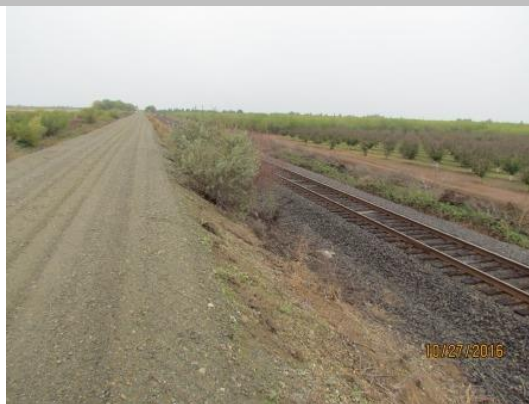
Photo 1 of 1 : SP_2018_RD0010_163_47_20180302_00018.jpg

View of a small willow tree that should be removed on the landside looking down stream. Fall 2016.

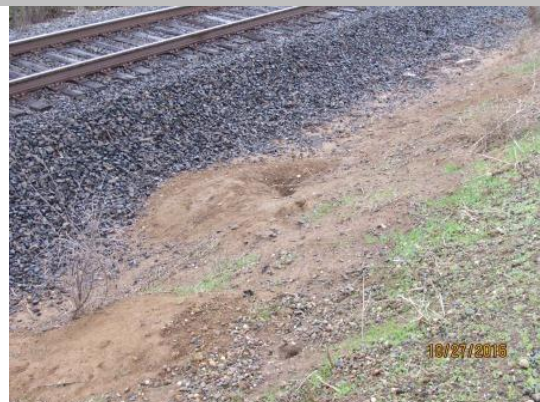
Photo 1 of 1 : SP_2018_RD0010_163_42_20180302_00015.jpg

View of squirrel hole on landside toe, no sign of activity. Fall 2016.

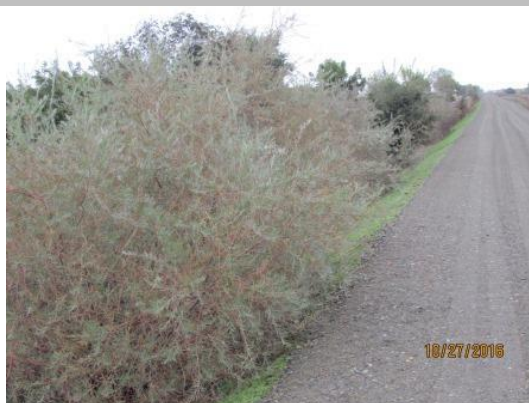
Photo 1 of 1 : SP_2018_RD0010_163_40_20180302_00013.jpg

View of willow trees on the landside slope looking upstream. Fall 2016.

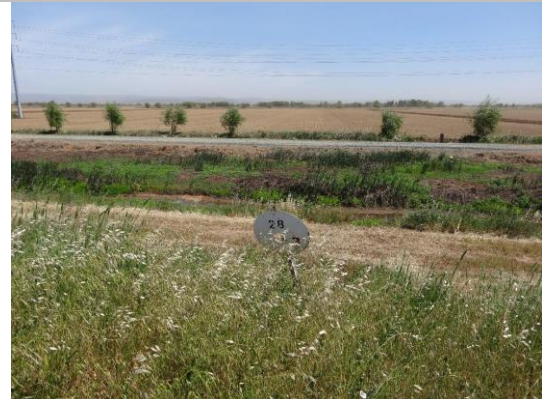
Photo 1 of 3 : UCIP_SP_2018_24438_43503.jpg

Marker visible on waterward shoulder.

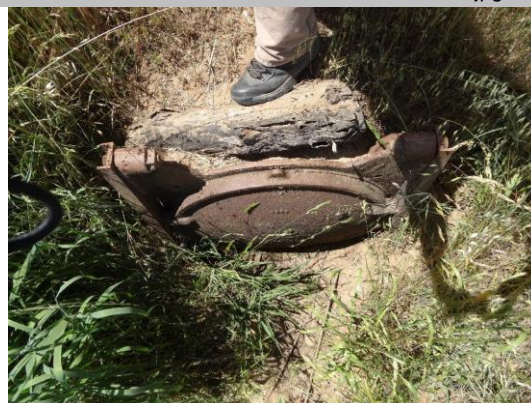
Photo 3 of 3 : UCIP_SP_2018_24438_43501.jpg

Pipe and flap gate confirmed on waterward side.

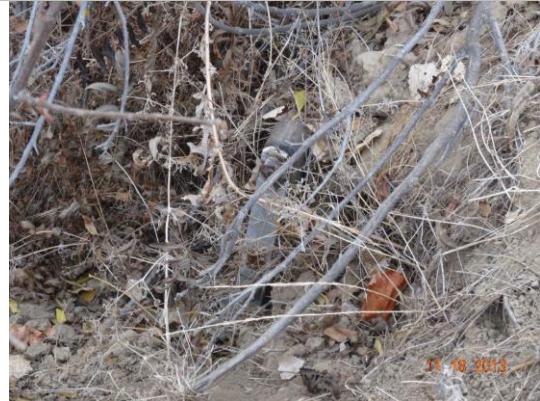
Photo 3 of 3 : UCIP_SP_2018_27533_51138.jpg

Buried flap gate on waterward side.

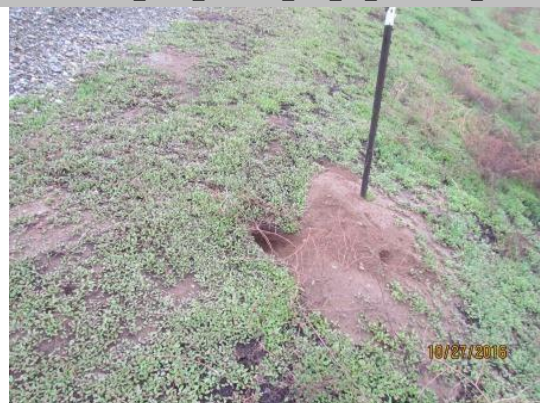
Photo 1 of 1 : SP_2018_RD0010_164_28_20180302_00003.jpg

View of squirrel hole on the waterside looking downstream. Fall 2016

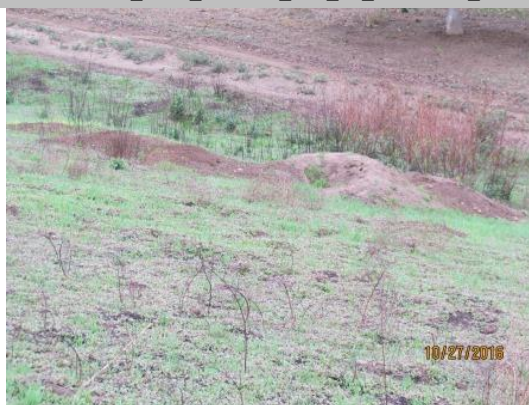
Photo 1 of 1 : SP_2018_RD0010_164_30_20180302_00005.jpg

View of rodent hole that has more than 2 cubic feet of material on the waterside.

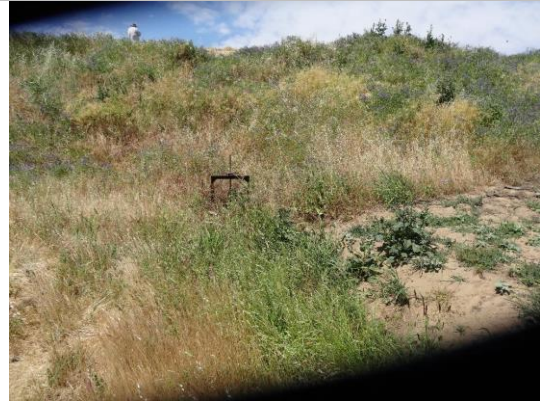
Photo 3 of 3 : UCIP_SP_2018_24751_44373.jpg

View of landward side--dense vegetation.

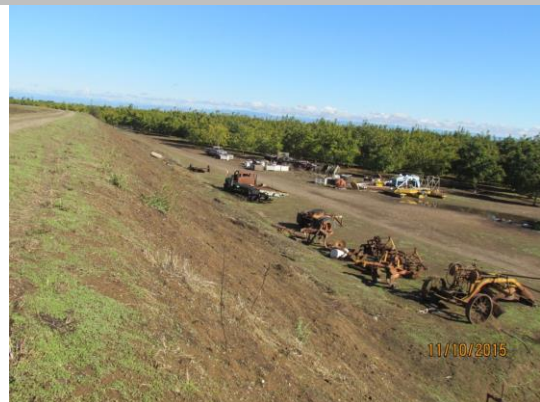
Photo 1 of 2 : SP_2018_RD0010_164_31_20180302_00006.jpg

View of the equipment at the toe of the levee on the landward side of the levee looking upstream. Fall 2015.

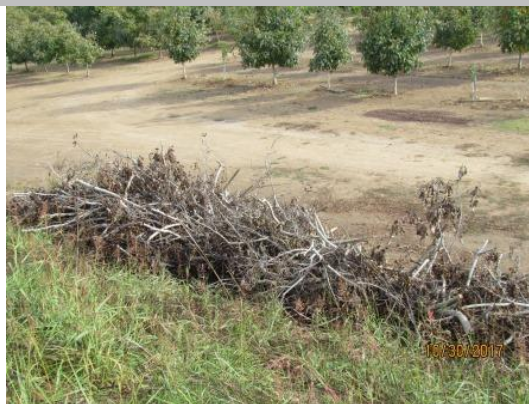
Photo 1 of 1 : SP_2018_RD0010_164_46_20180302_00020.jpg

View of pruning's at the landside levee toe, Fall 2017.

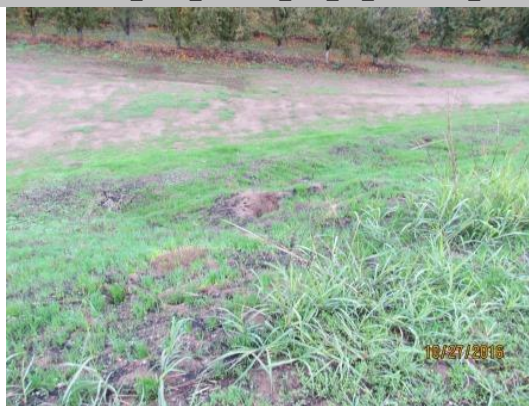
Photo 1 of 1 : SP_2018_RD0010_164_50_20180302_00023.jpg

View of rodent hole on landside slope. Fall 2016.

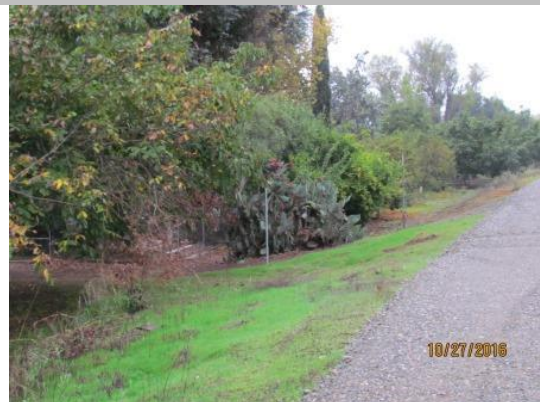
Photo 1 of 1 : SP_2018_RD0010_164_37_20180302_00013.jpg

View of the cactus on the landward side of the levee looking downstream.

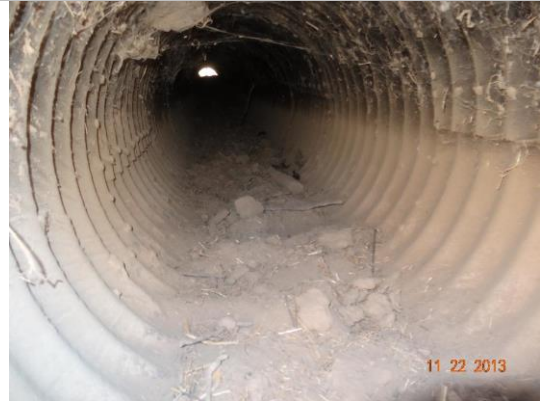
Photo 3 of 3 : UCIP_SP_2018_24840_44751.jpg

Internal view of pipe wall from waterward side.

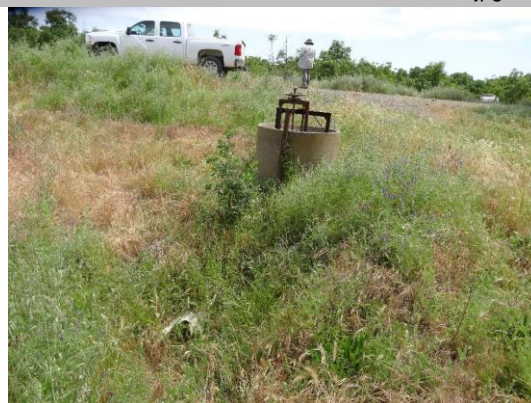
Photo 2 of 3 : UCIP_SP_2018_24841_44757.jpg

View of concrete standpipe and plastic pipe extension visible on waterward side.
